Job No.: J-2296-07

Re: Avery Landing Recovery System

December 11, 1997

Re: Second Quarter Performance Report for 1997
Avery Landing Recovery System

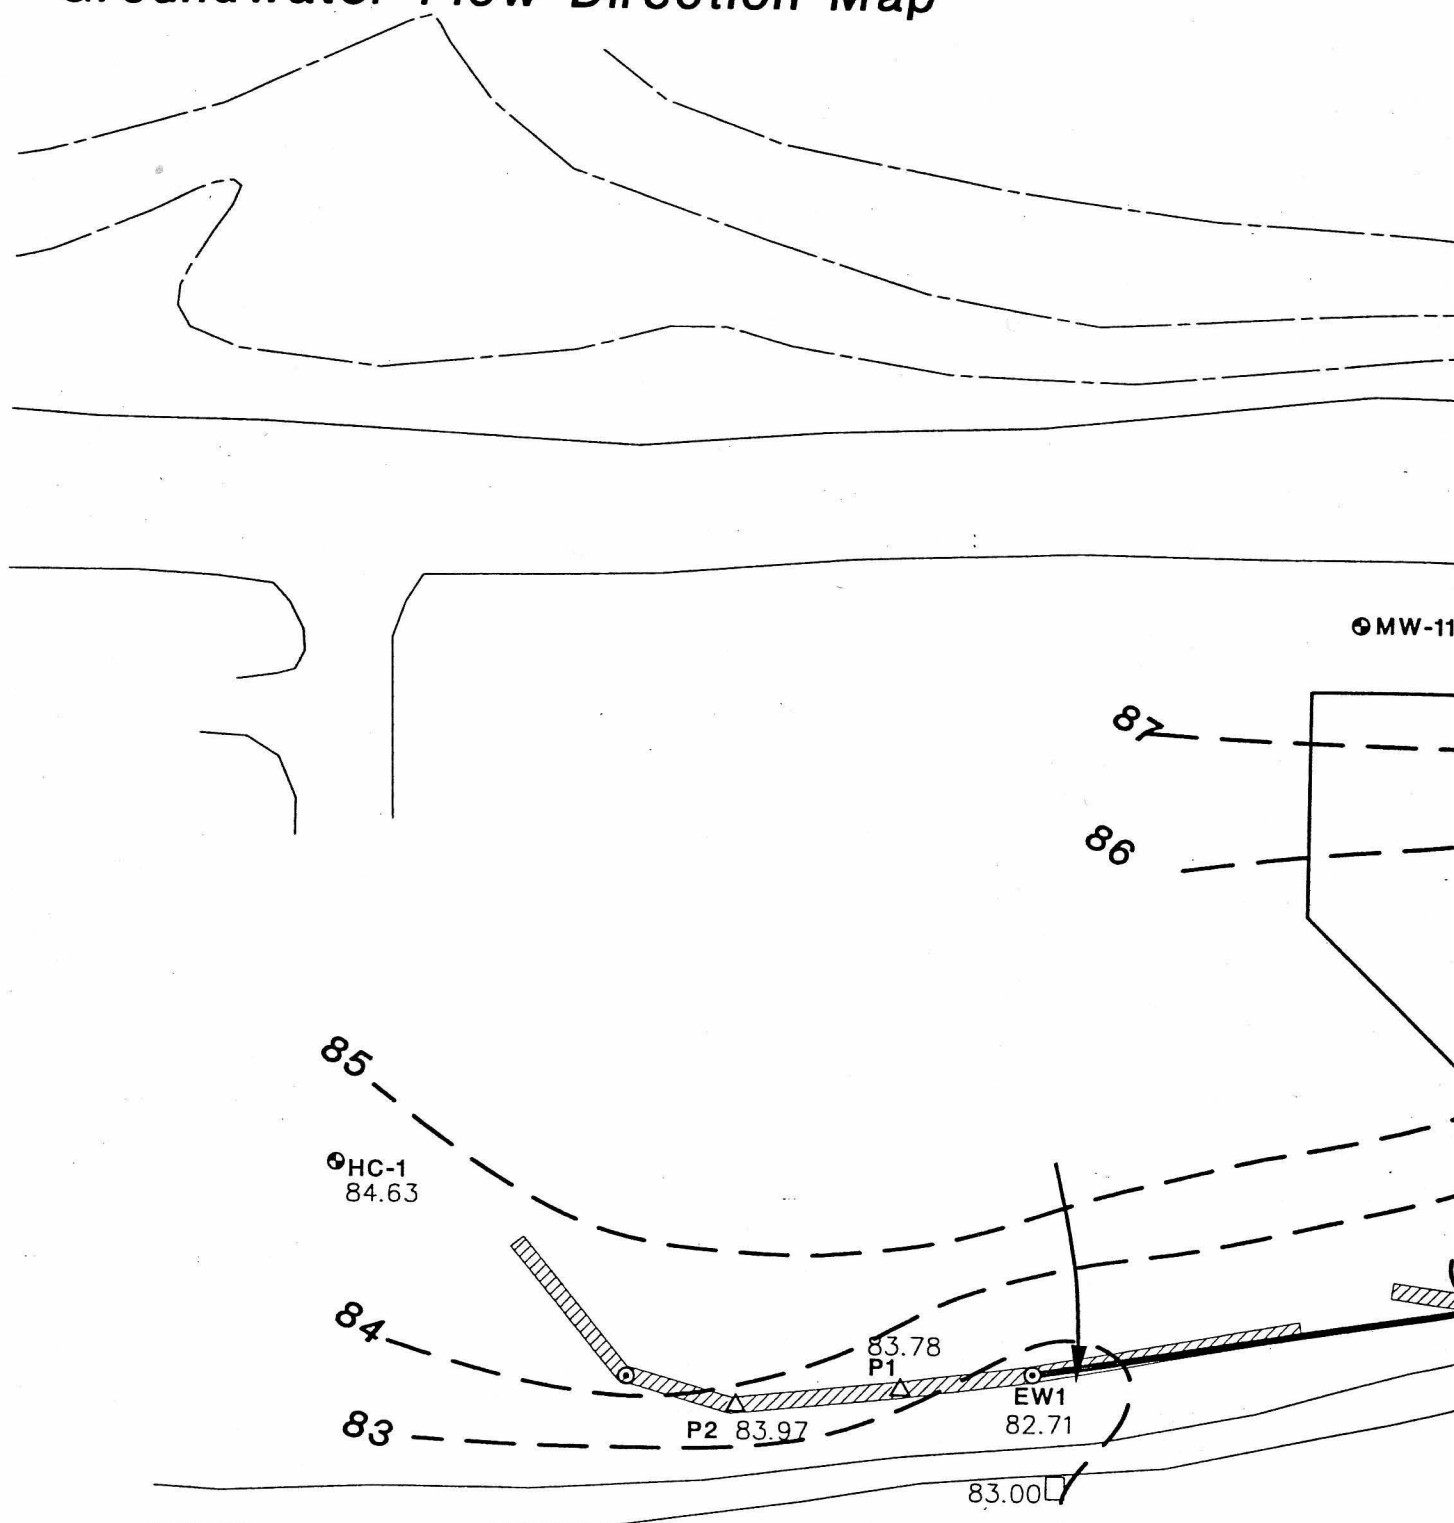
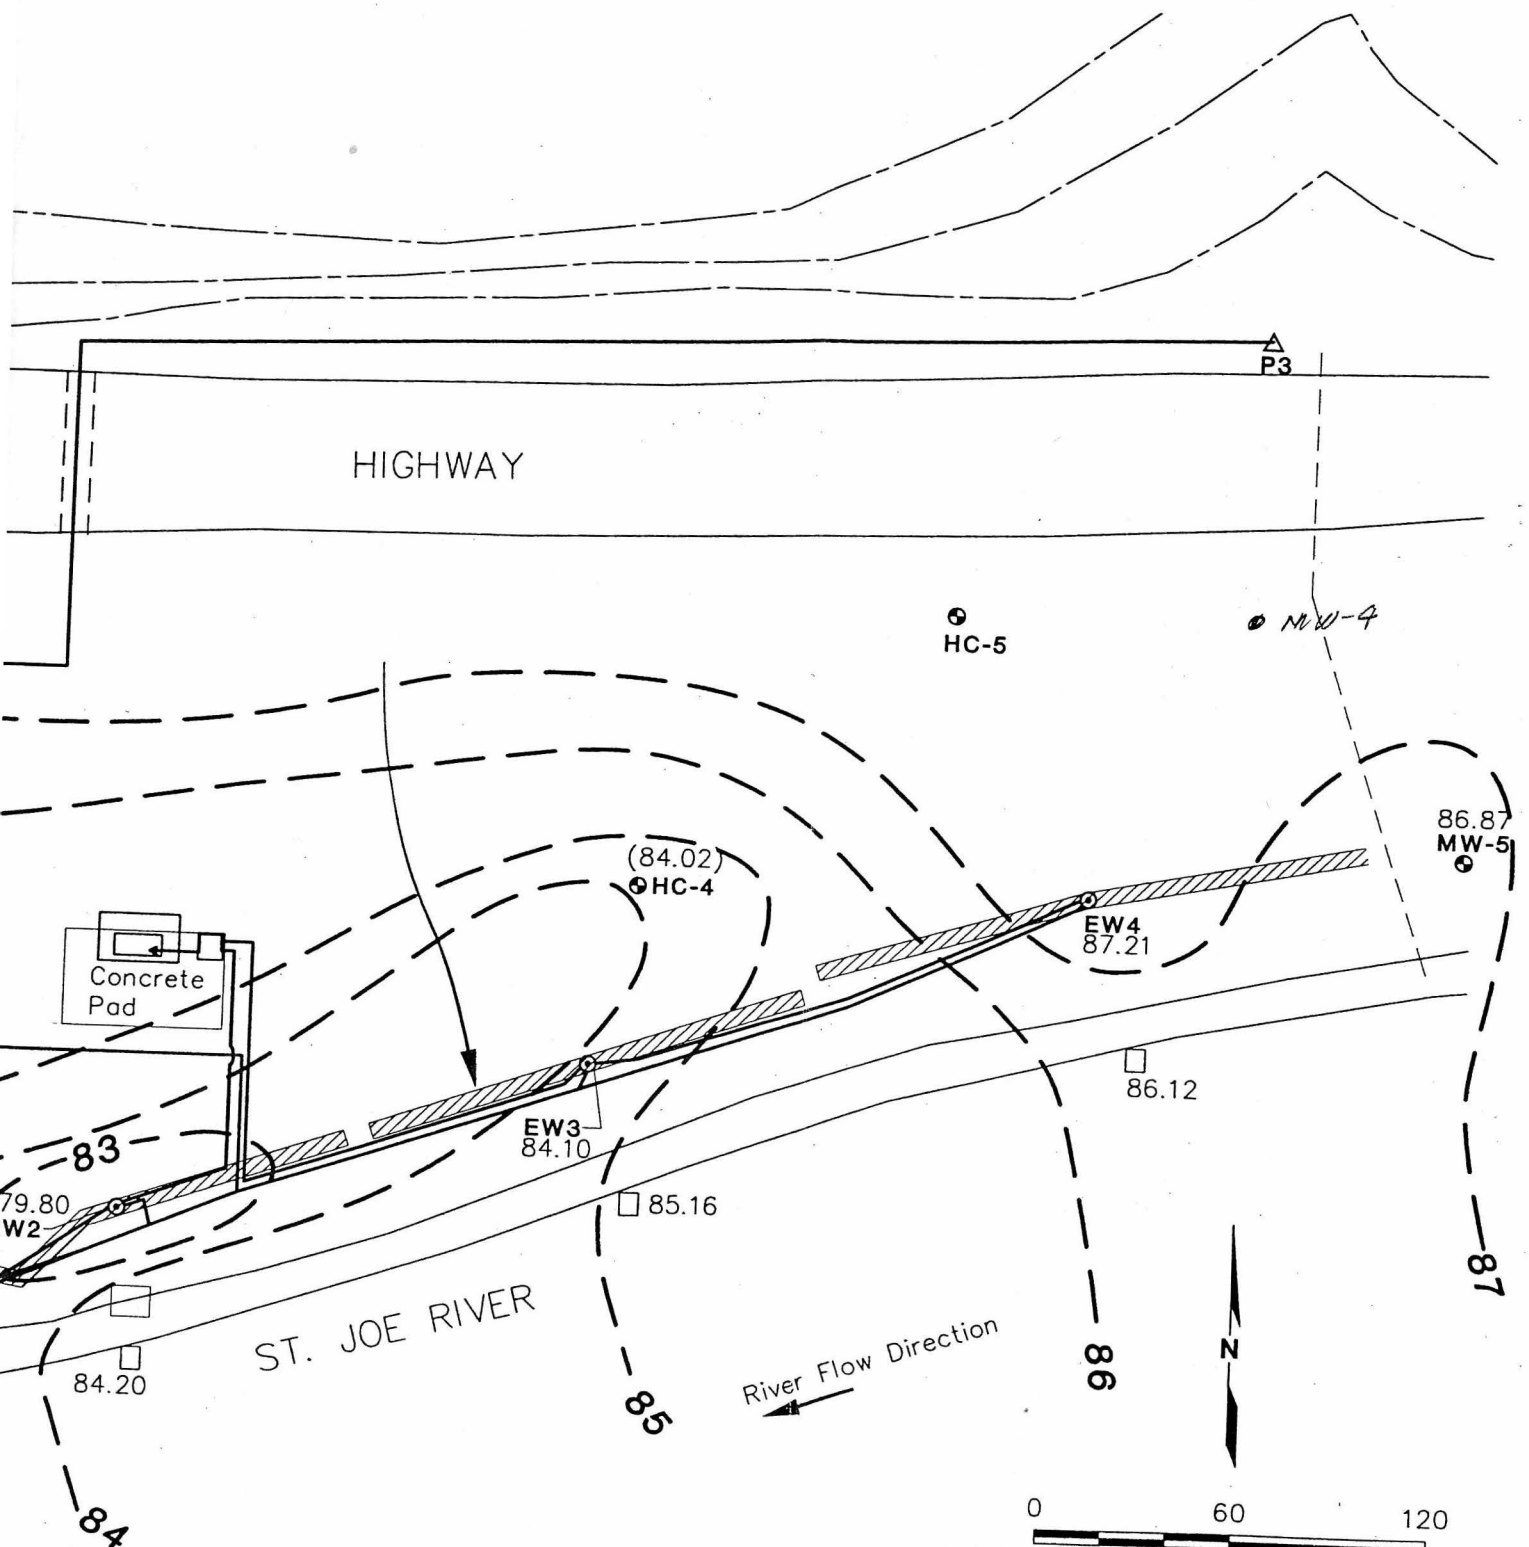
Figure 1

Four extraction wells (EW-1, EW-2, EW-3, and EW-4), three monitoring wells (HC-1, HC-4, and MW-5), and two piezometers (P-1, and P-2) were monitored on October 9, 1997. The locations of the monitoring points are shown on Figure 1. At each monitoring location, depth to product, product thickness, and depth to groundwater measurements were recorded. These measurements are presented with those of previous monitoring rounds in Table 1 at the end of the text. If a location indicated the presence of product but we were unable to obtain product-related

Extraction well EW-3 contained 0.78 foot of product. Extraction wells EW-2 and EW-4 each had a trace of product detected. Well HC-4 continues to have product present, with a thickness of 2.25 feet detected during the current monitoring round. Wells EW-1, HC-1, MW-5, and the piezometers did not indicate the presence of product.

Though the system was not maintaining absolute containment, the depression in the groundwater level does appear to be collecting most of the free product. Some oil was seen seeping into the river from an area due south of EW-3 that had been eroded during the spring flooding. The oil booms were moved to intercept this oil. We do not believe this oil moved past the treatment system, but was already past the system before treatment began. The oil seeping into the river is very thick, whereas the oil being recovered directly upgradient is much thinner.
